Documentation of Character-Defining Features

Tidewater Farm Falmouth ME

2020

Scott T. Hanson

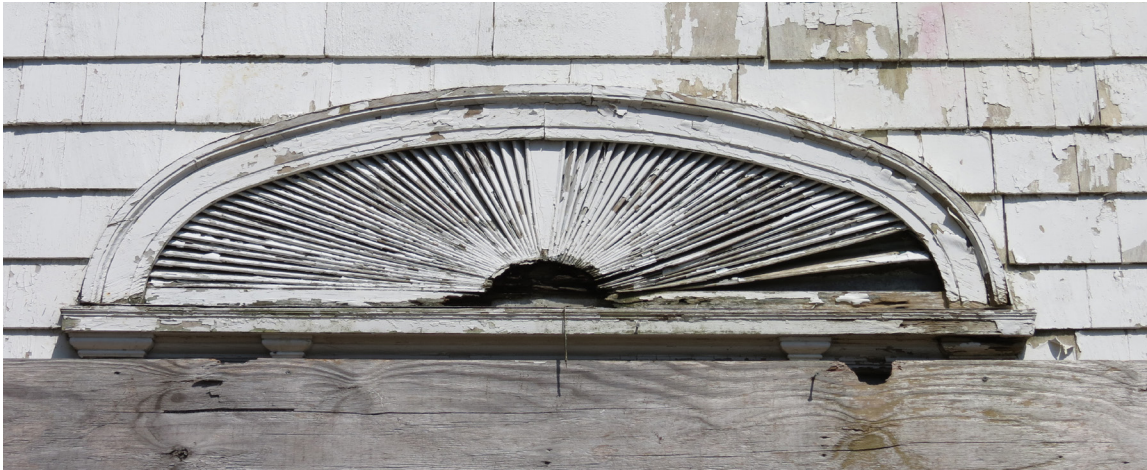
Photo 1: Front door surround including elliptical louvered fan.

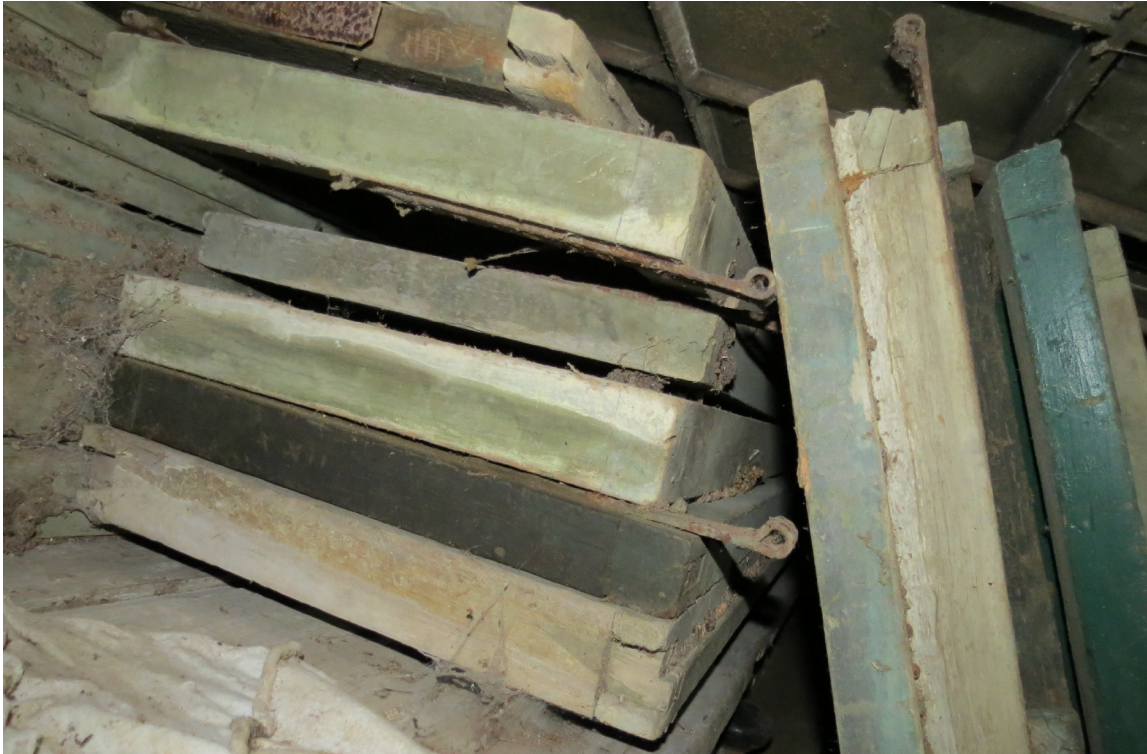
Photo 2: Early louvered shutters with hand-forged hinges (stored in garage). Not keyed.

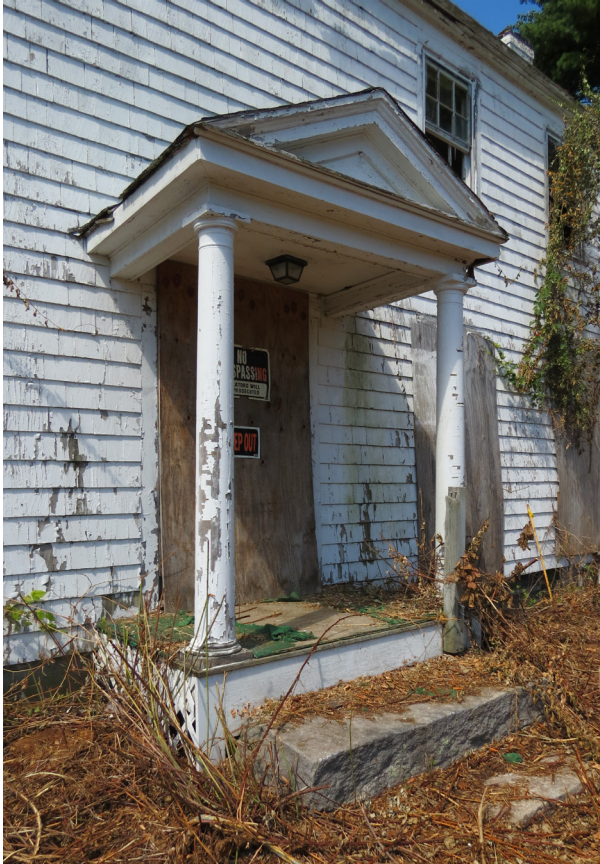
Photo 3: Mid-19th century Greek Revival door portico on side elevation.

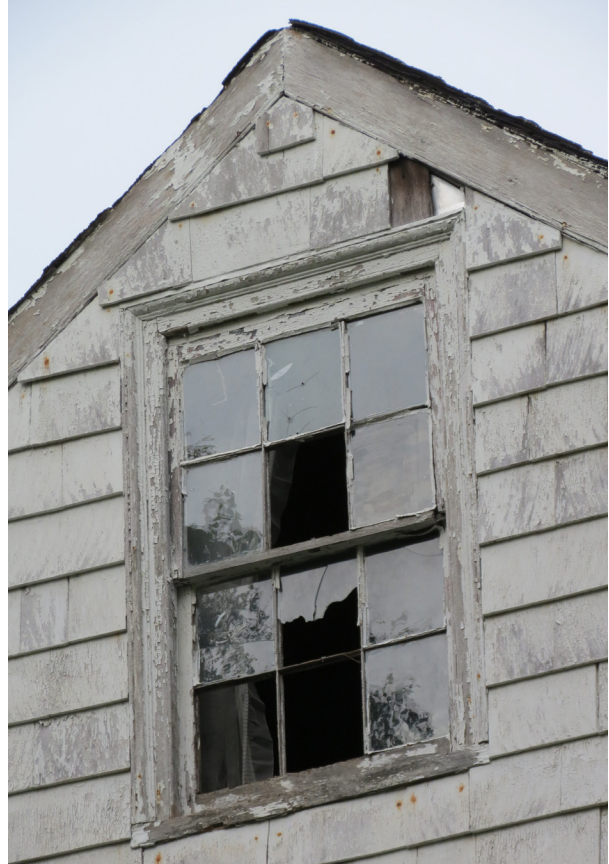
Photo 4: A few wood windows with early glass remain intact.

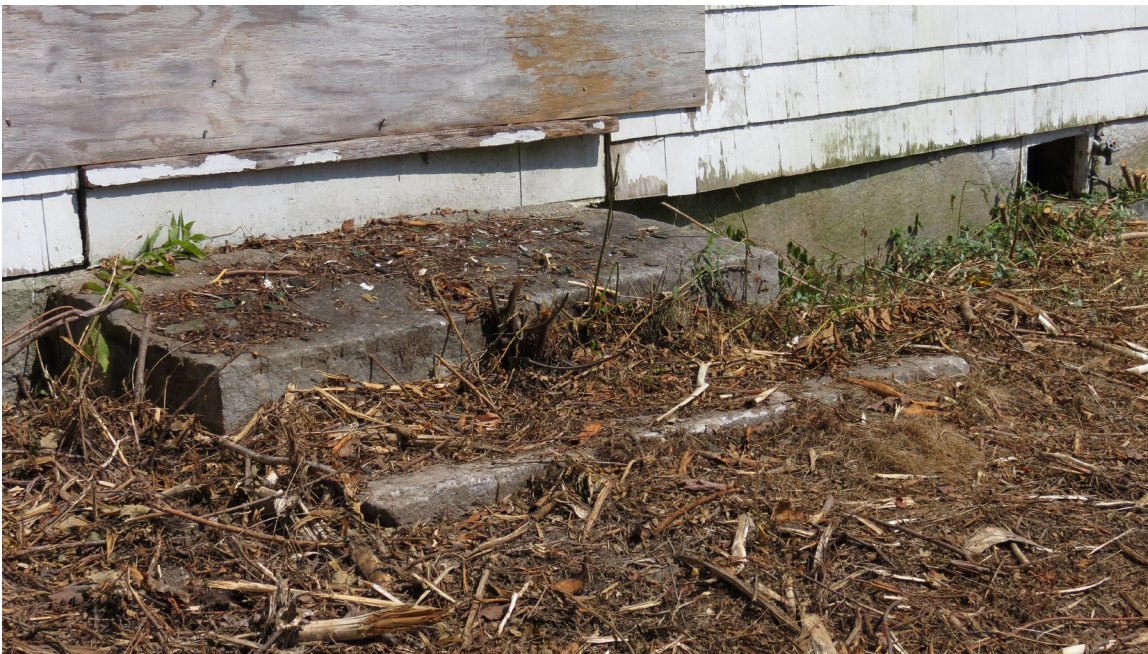
Photo 5: Granite steps at front and side doors, and granite cap stones on foundation.

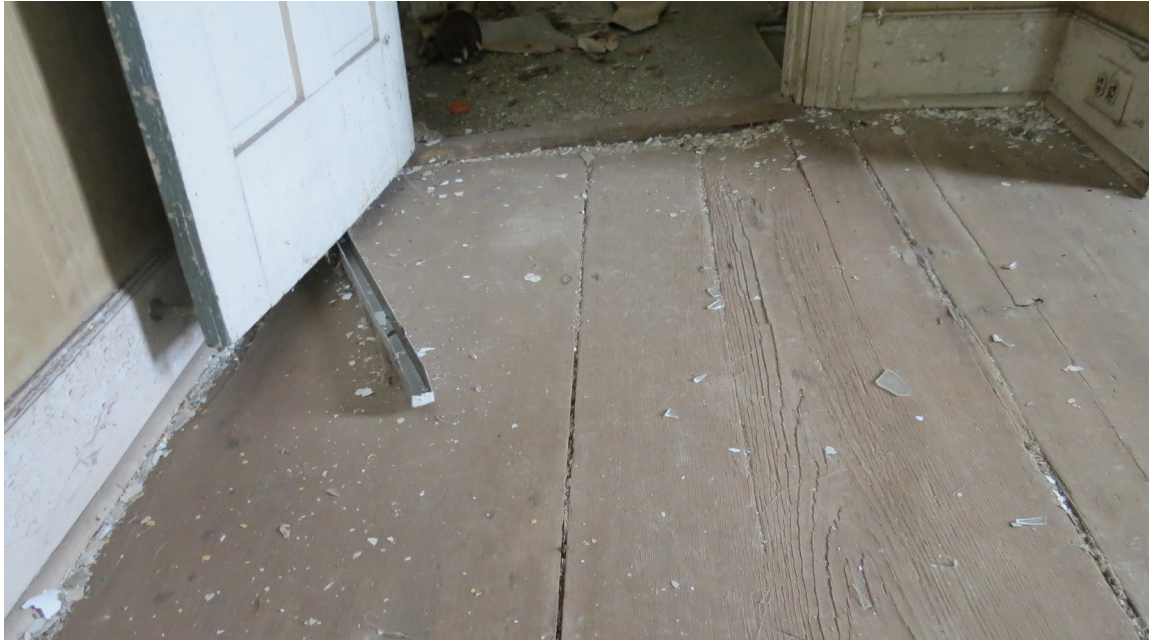
Photo 6: Wide board pine floors (some boards exceed 24" width).

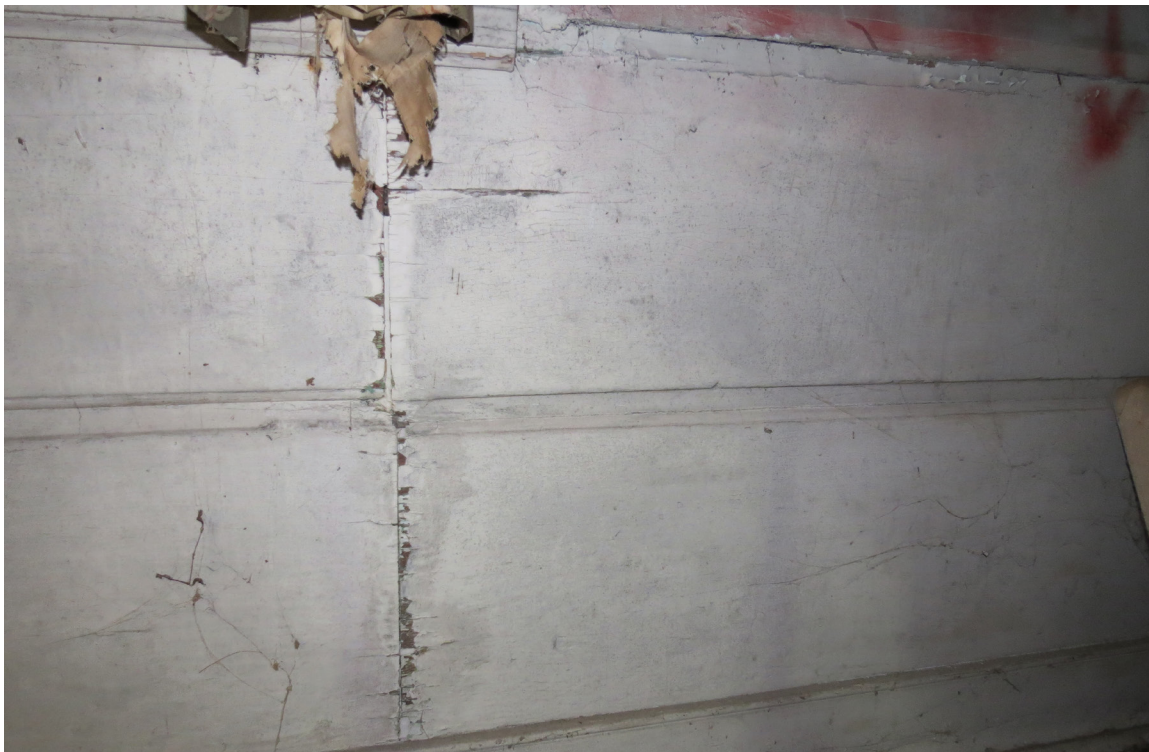
Photo 7: Horizontal wide board wainscoting.

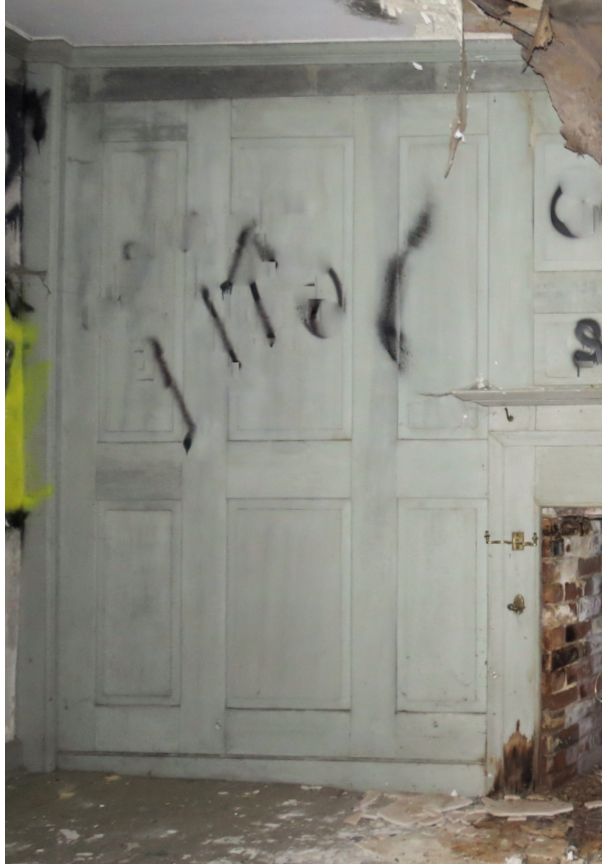
Photo 8: Raised wall paneling.

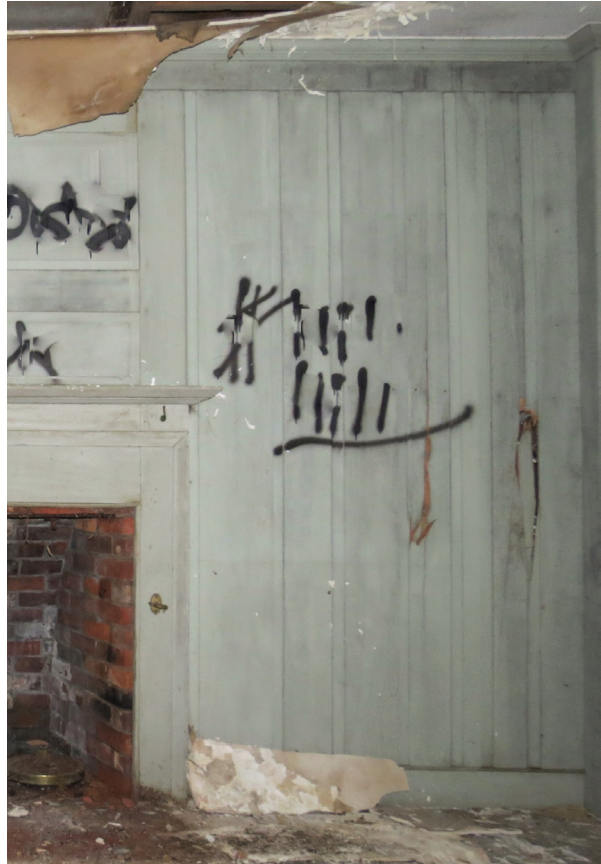
Photo 9: Vertical wide board paneling.

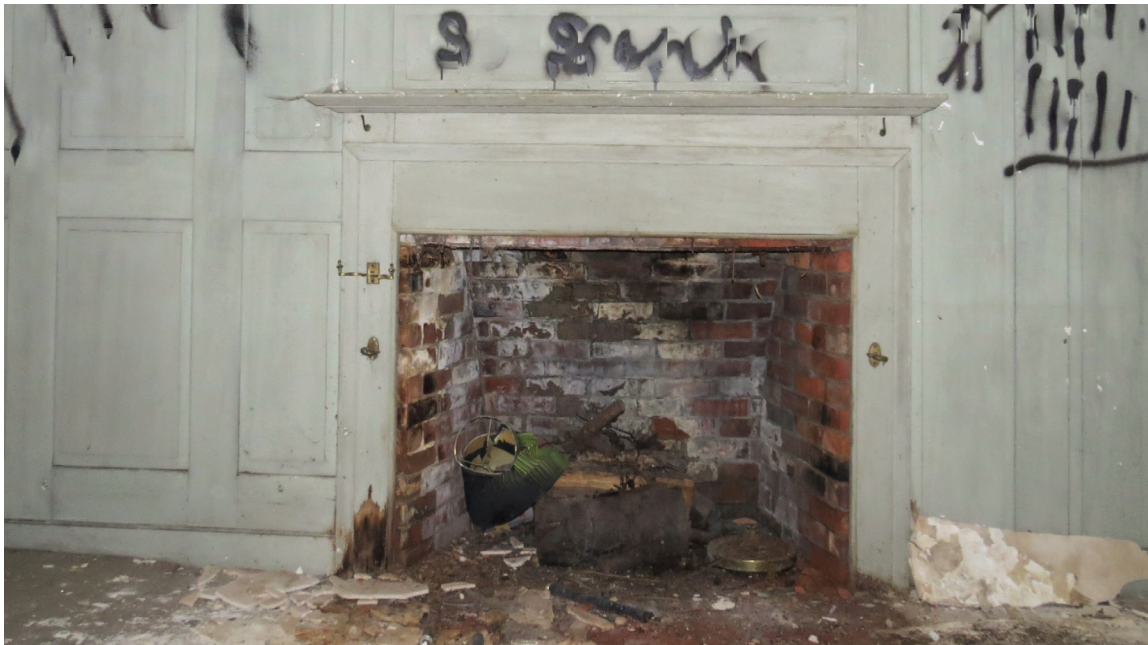
Photo 10: Federal Style mantel in living room. This chimney was moved at some point and the mantel and paneling relocated. Note raised panels on one side of the mantel and vertical board on the other.

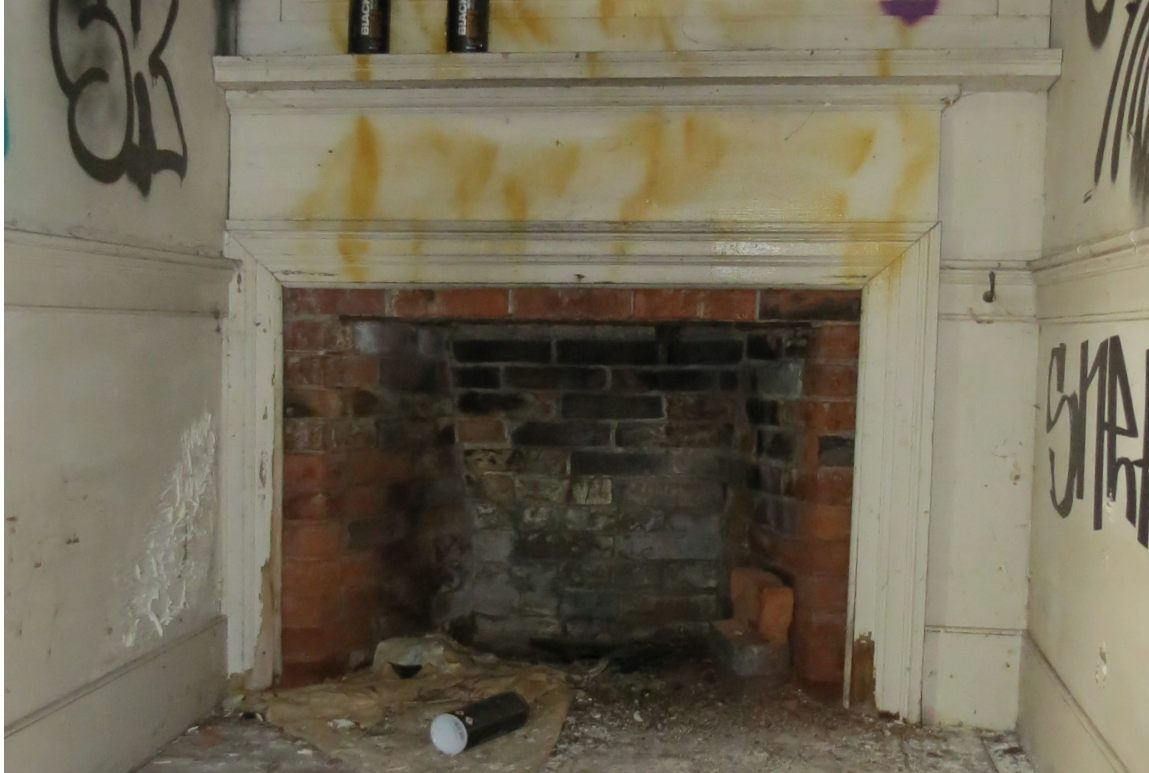
Photo 11: Federal style mantel in bedroom

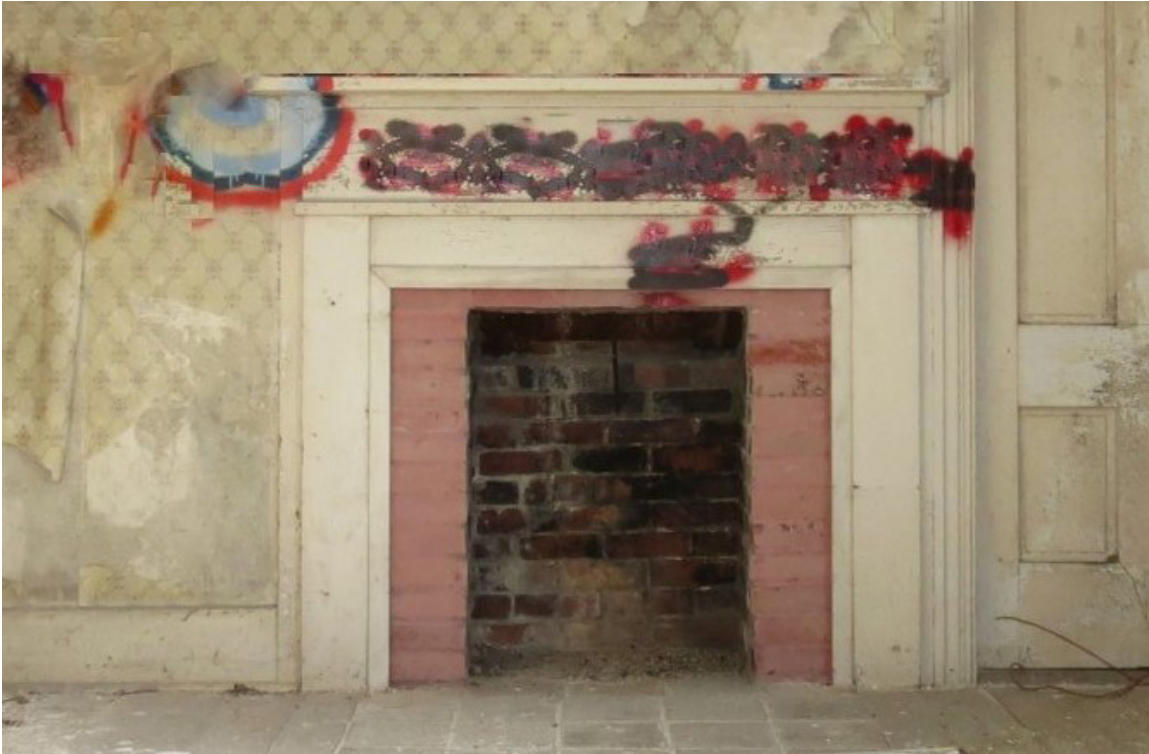
Photo 12: Greek Revival Mantel in bedroom.

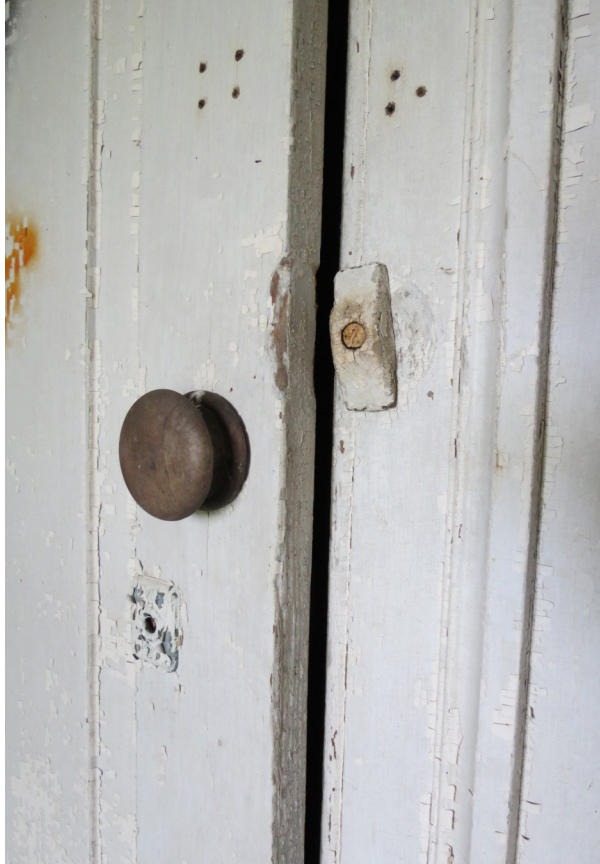
Photo 13: Federal style door trim and hardware.

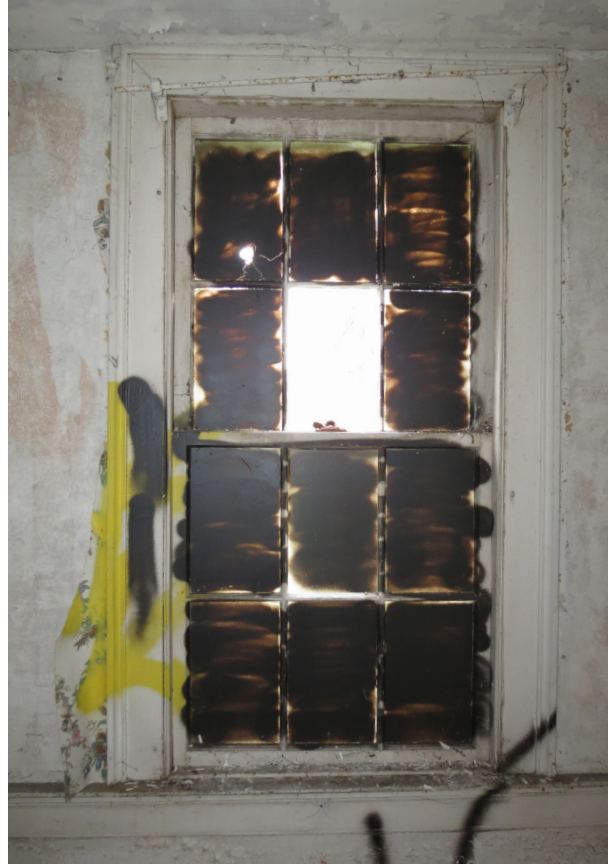
Photo 14: Federal style window trim and chair rail sill.

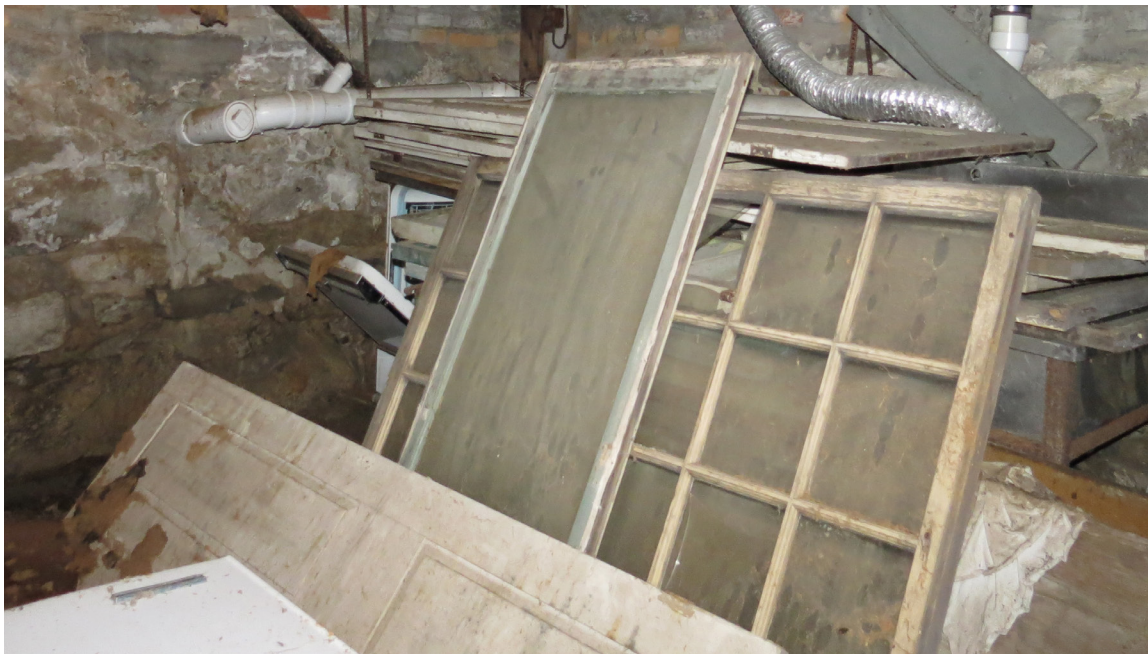
Photo 15: 19th century doors throughout the house and stored in the garage. Not keyed.

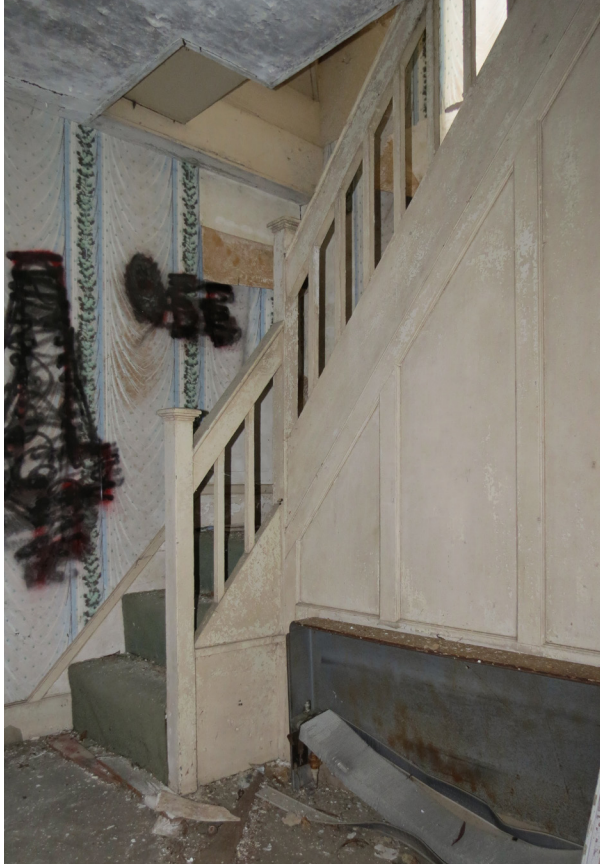
Photo 16: Early 20th century Colonial Revival stair elements.

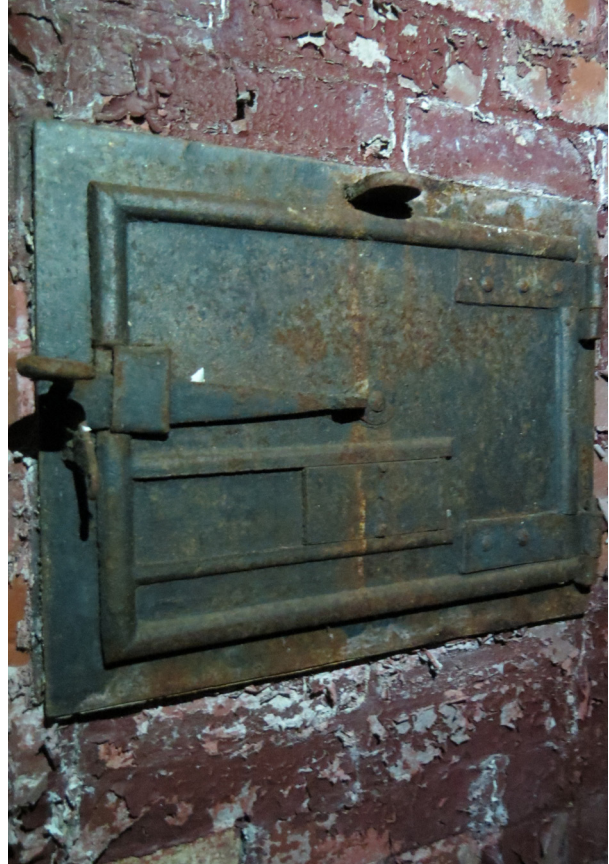
Photo 17: Early 19th century oven door with hand-forged hinges and latch.

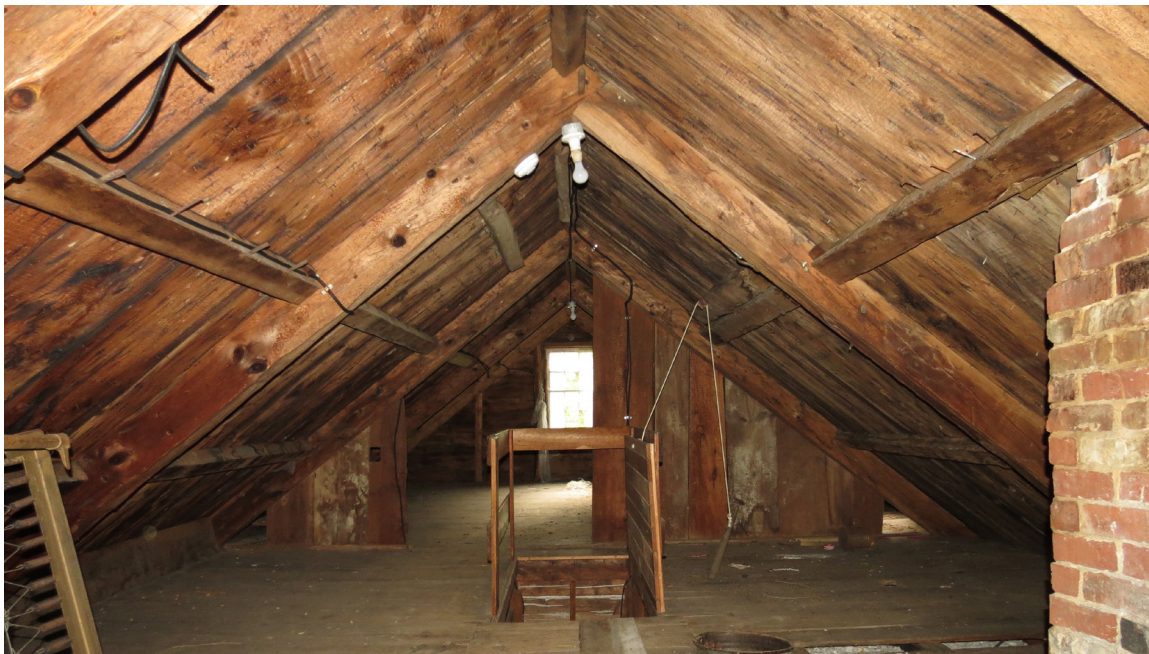
Photo 18: Old growth timber structural frame of house, rough-sawn wide sheathing boards, and historic brick in chimneys. Not keyed.

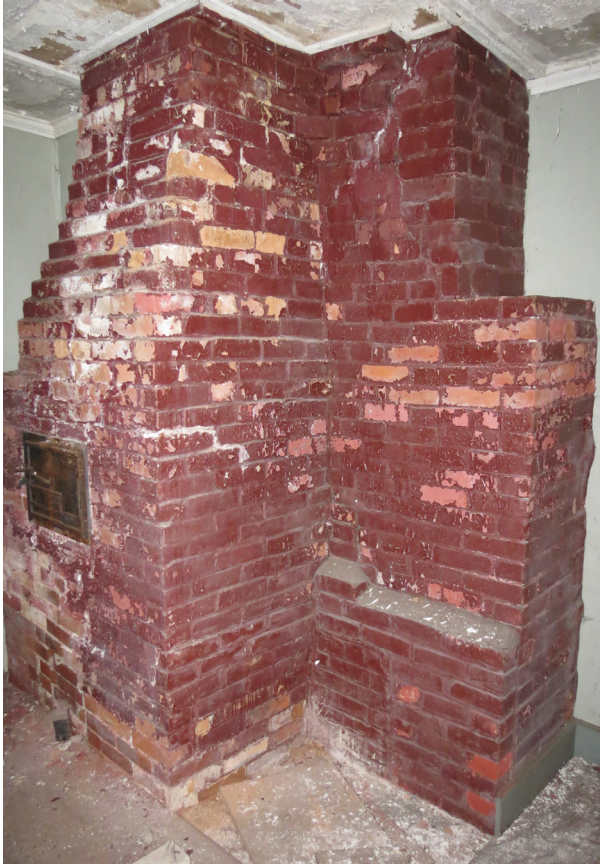
Photo 36: View of exposed chimney and early 19th century oven door in kitchen.

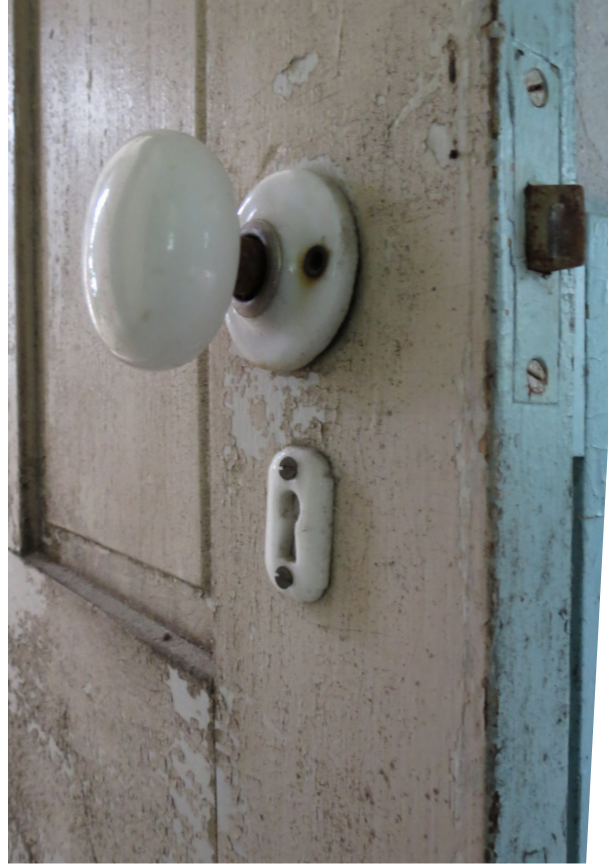
Photo 51: Detail of Victorian era door hardware in second story of ell. Not keyed.

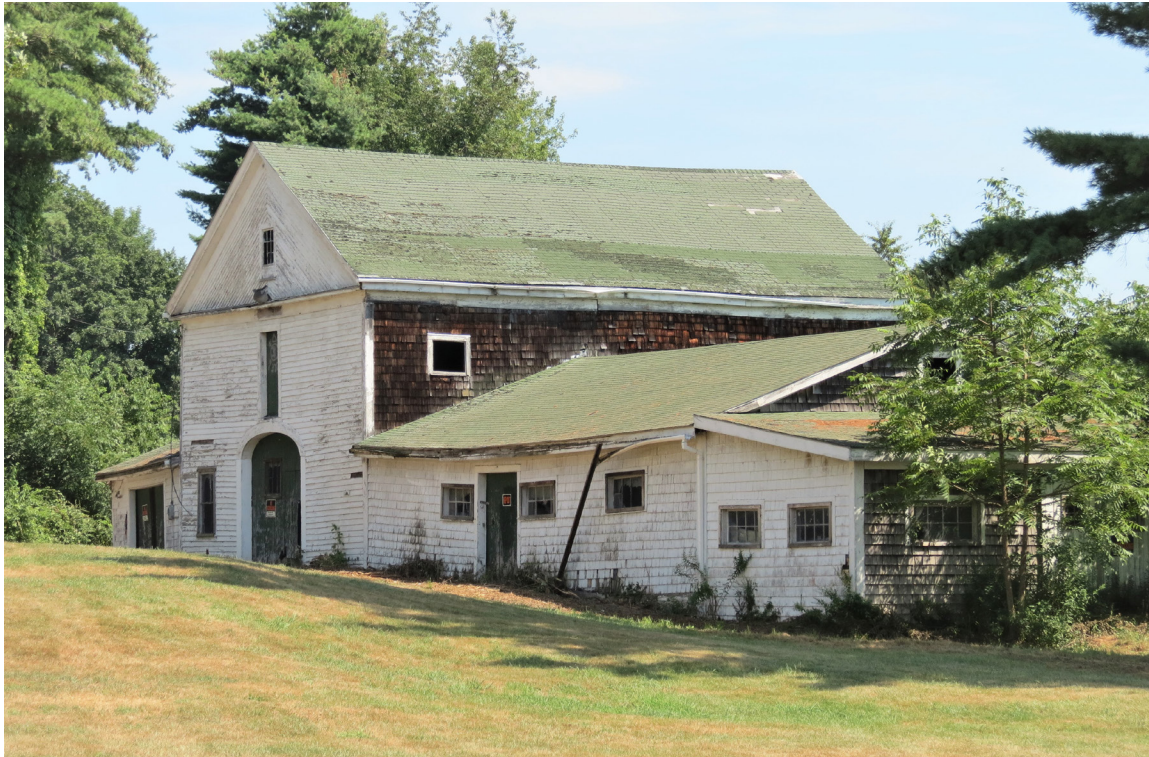
Photo 54: The two-story 19th century portion of the barn retains its historic clapboard siding and trim on the facade.

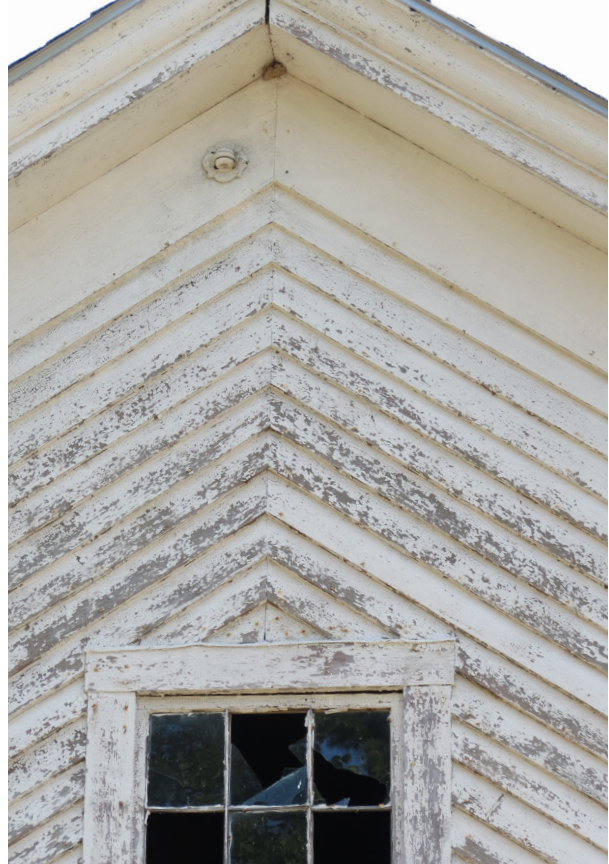
Photo 56: Historic clapboard, trim, and window in barn.

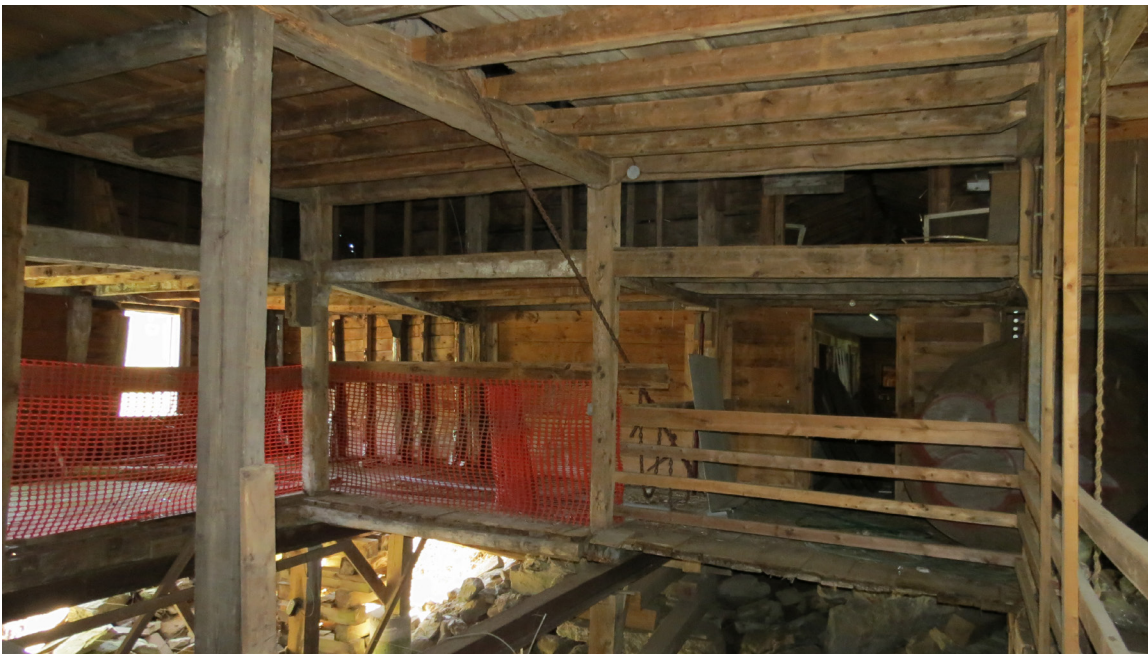
Photo 57: Old growth timber barn frame. Not keyed.

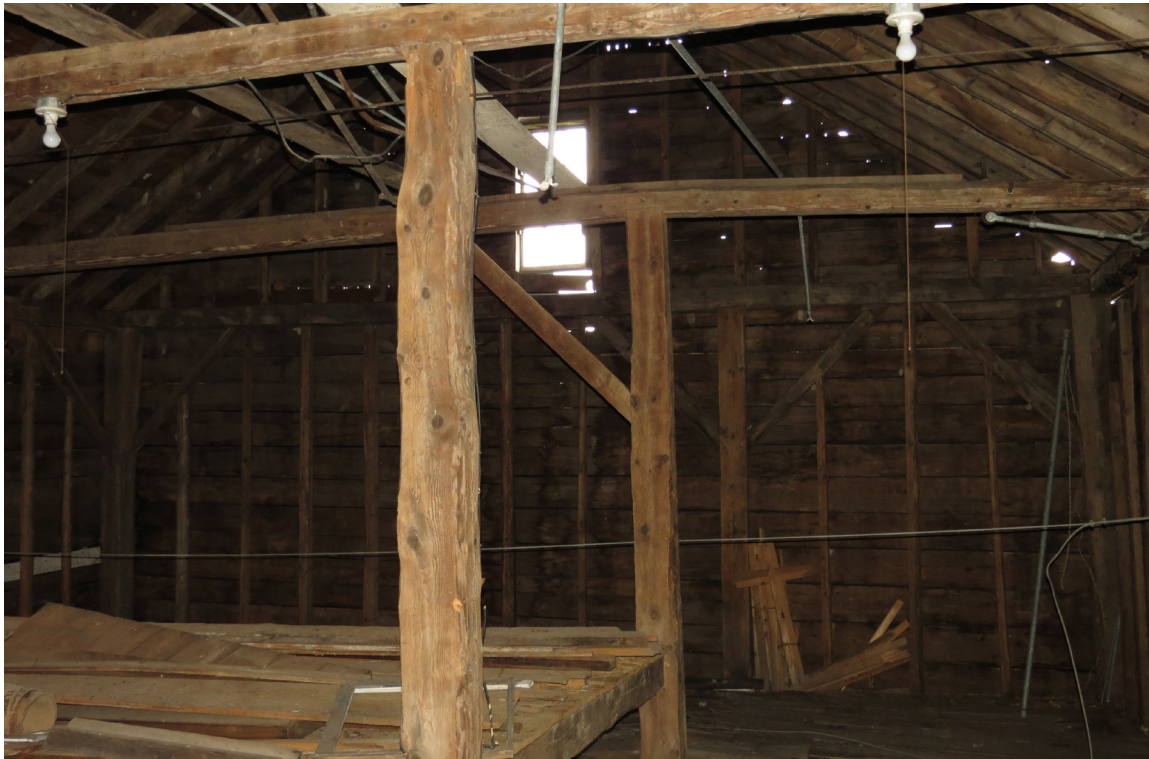
Photo 58: Old-growth timber barn frame. Not keyed.

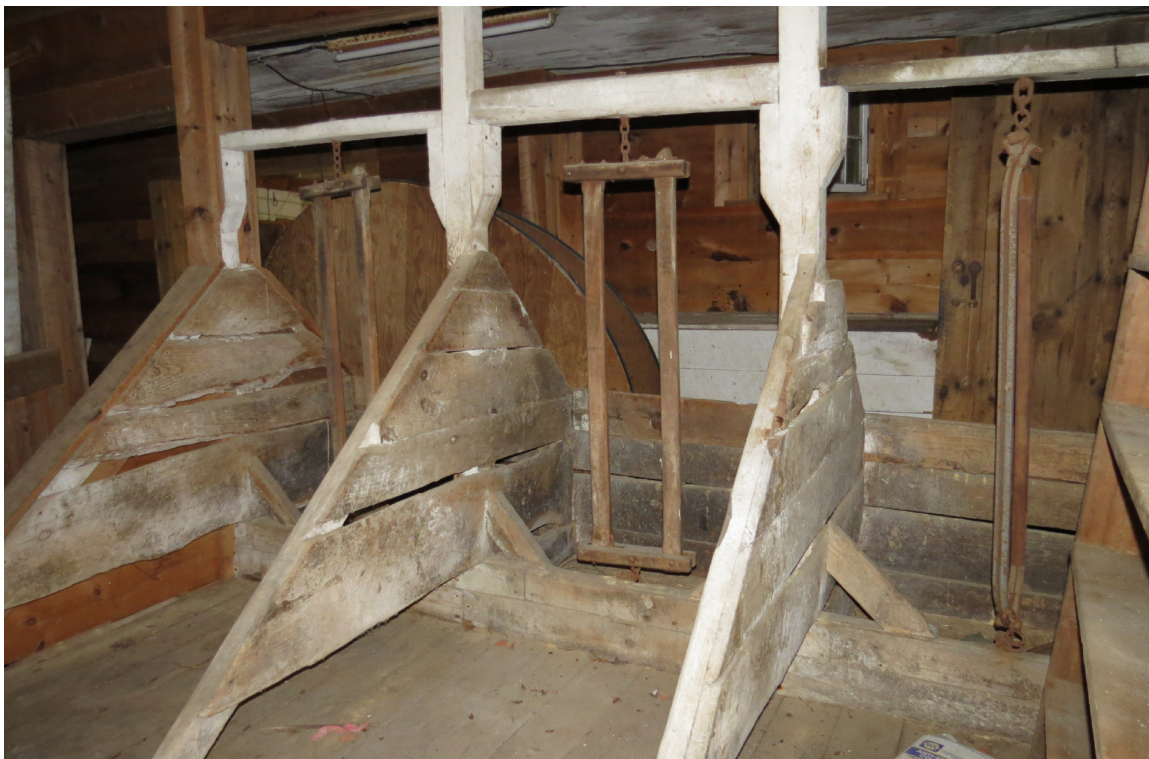
Photo 59: Cow tie-ups in barn. Not keyed.

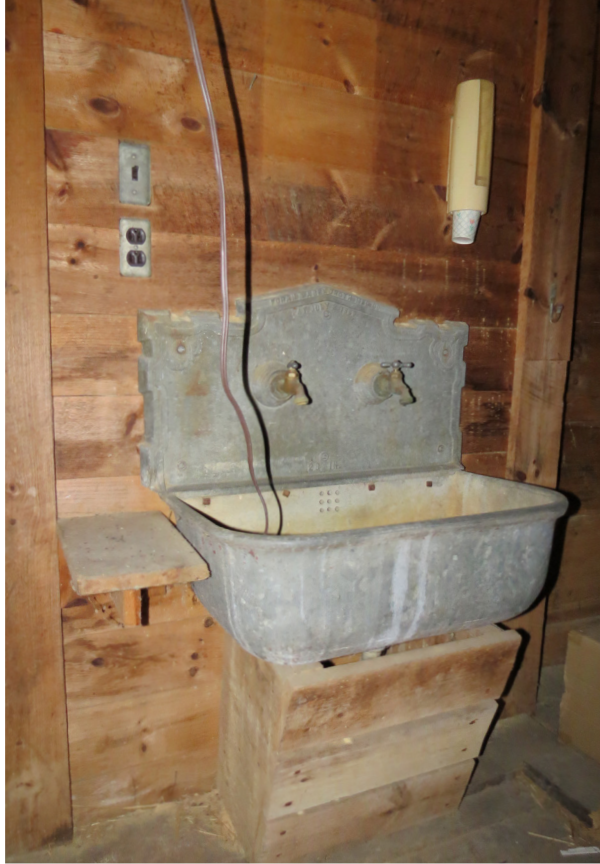
Photo 60: Vintage water trough/sink in barn. Not keyed.

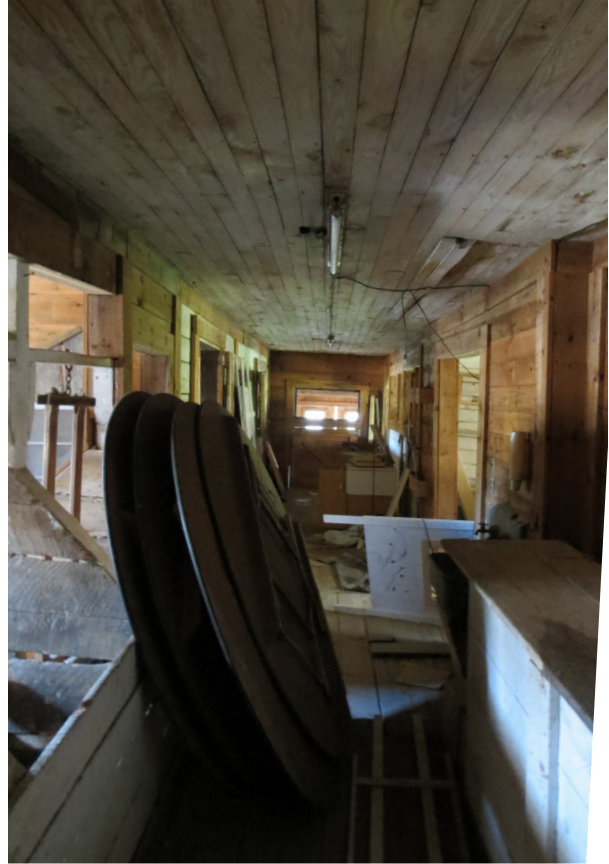
Photo 61: Later additions to the barn have little historic material for salvage. Not keyed.
